Operation and Maintenance Plan for INTEC
Operable Unit 3-13, Group 1, Tank Farm Interim Action
DOE/ID-10771

Summary of Verification and Inspection Reports Generated for TFIA

Appendix D Photographs of the TFIA Construction

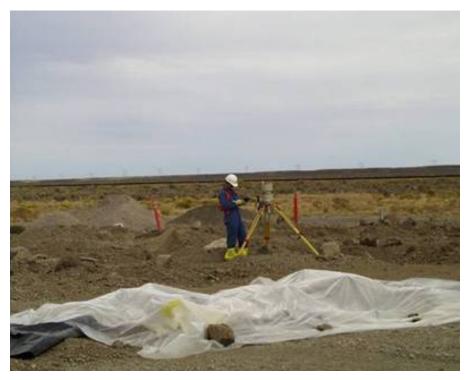
Figure D-1. Gamma scanning at evaporation pond location.

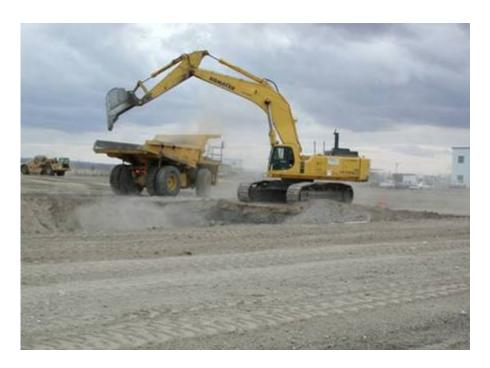
Figure D-2. Start of evaporation pond excavation.

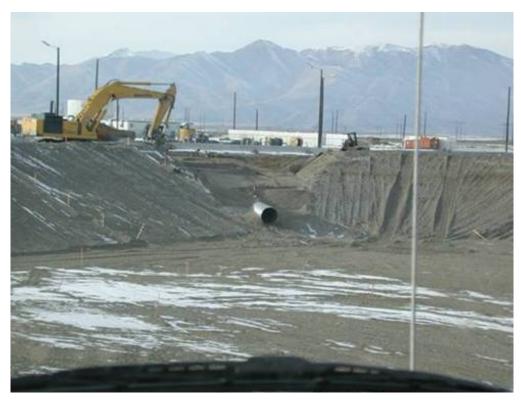
Figure D-3. Evaporation pond excavation.

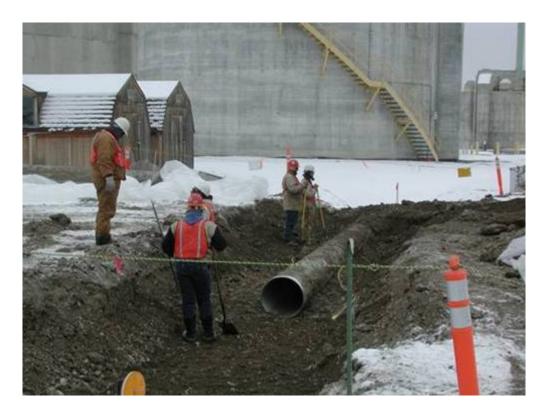
Figure D-4. Culvert removal east of the tank farm.

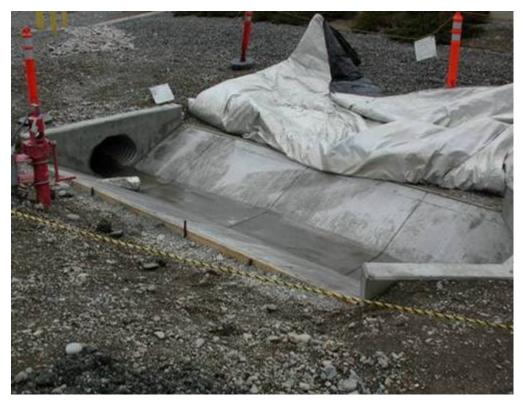
Figure D-5. Concrete headwall and endwall east of the tank farm.

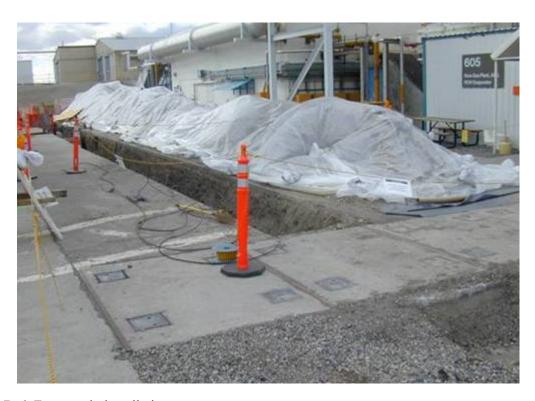
Figure D-6. Force main installation.

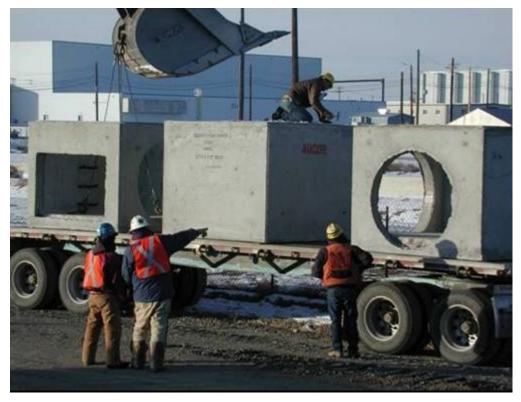
Figure D-7. Pre-cast manholes.

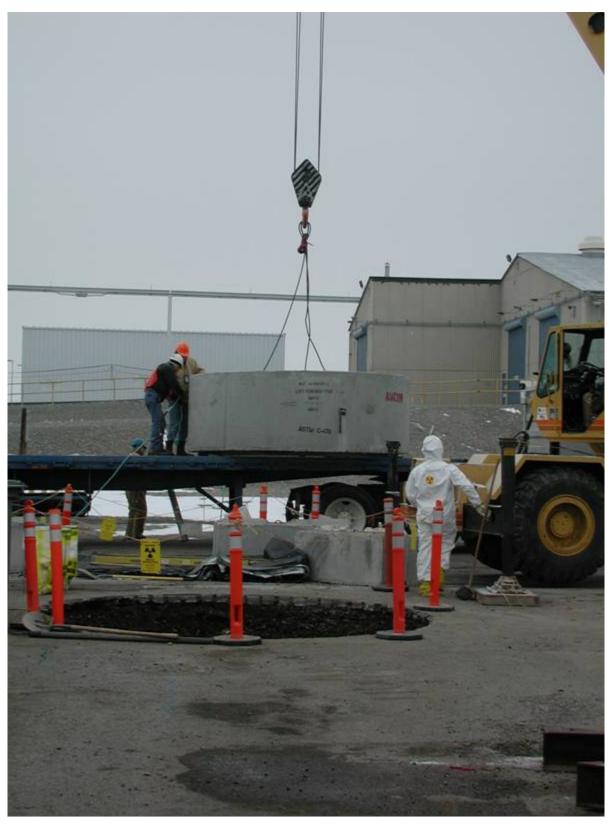
Figure D-8. Lift station installation.

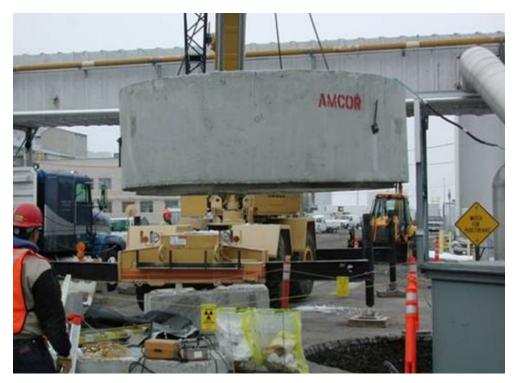
Figure D-9. Lift station installation close-up.

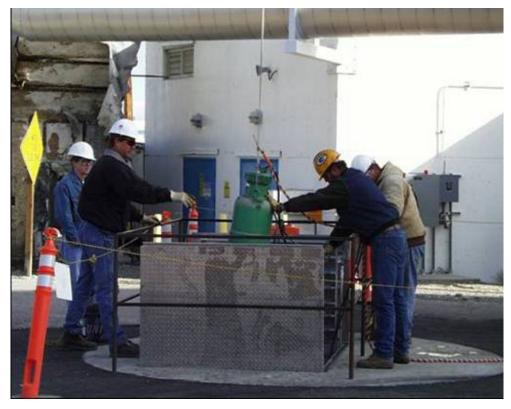
Figure D-10. Lift station pump installation.

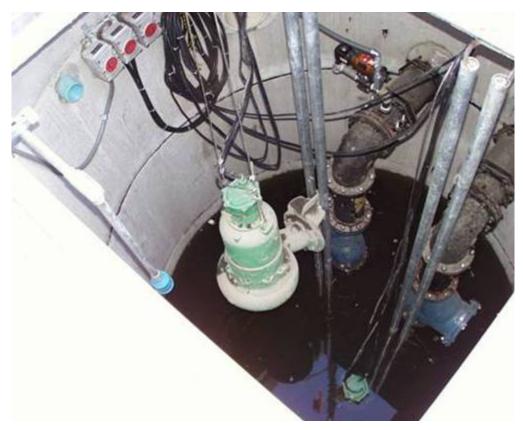
Figure D-11. Interior of lift station.

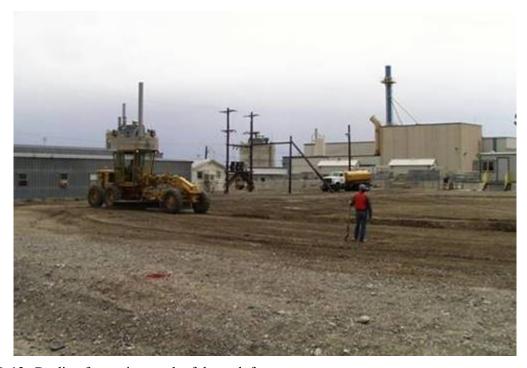
Figure D-12. Grading for paving north of the tank farm.

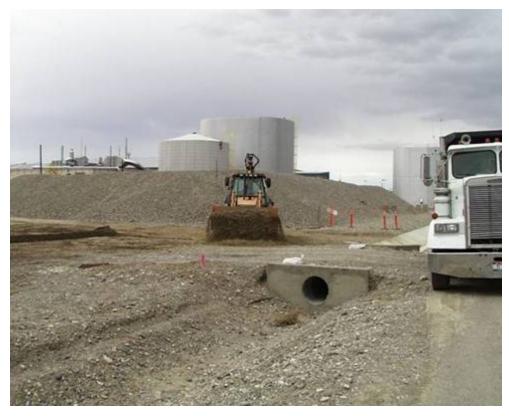
Figure D-13. Grading for paving and headwall north of the tank farm.

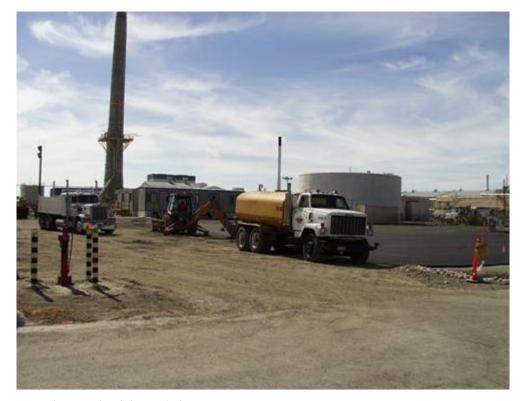
Figure D-14. Paving north of the tank farm.

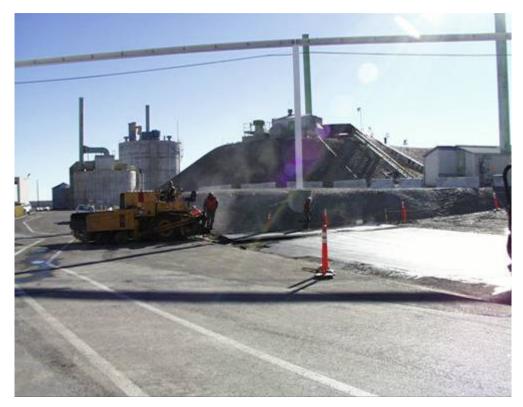
Figure D-15. Paving south of tank farm.

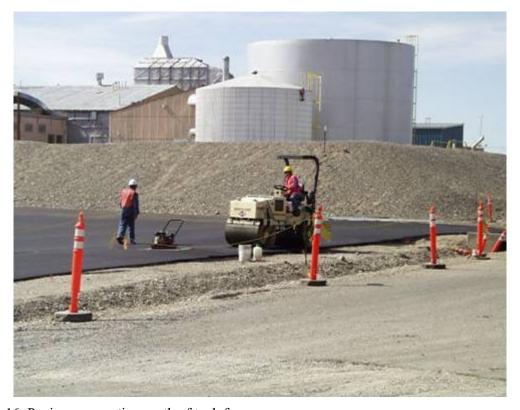
Figure D-16. Paving compaction north of tank farm.

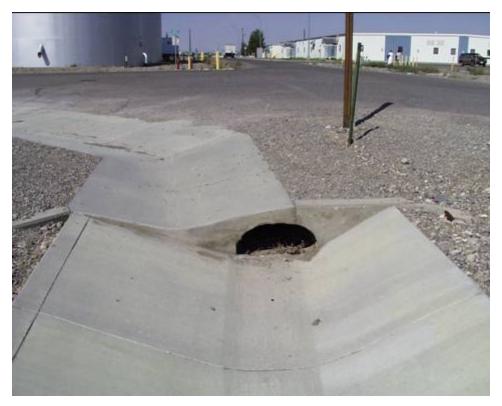
Figure D-17. Concrete ditches northwest of tank farm.

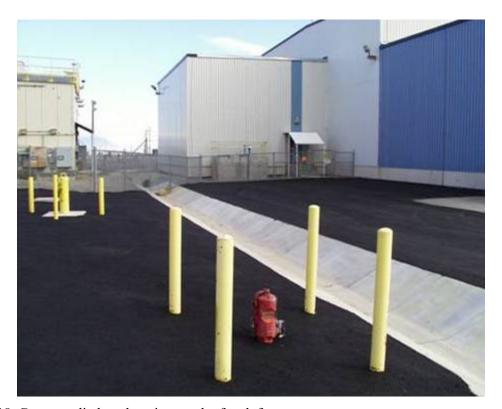
Figure D-18. Concrete ditch and paving south of tank farm.

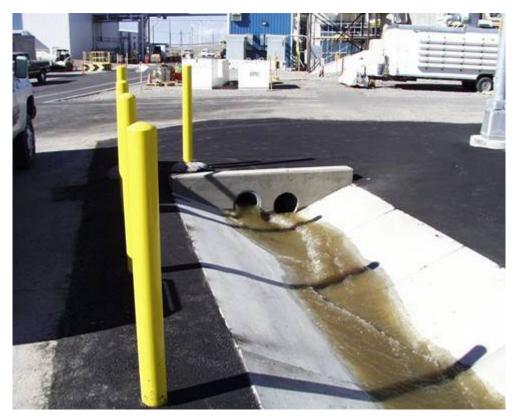
Figure D-19. Lift station system operation test - water flowing out of force main.

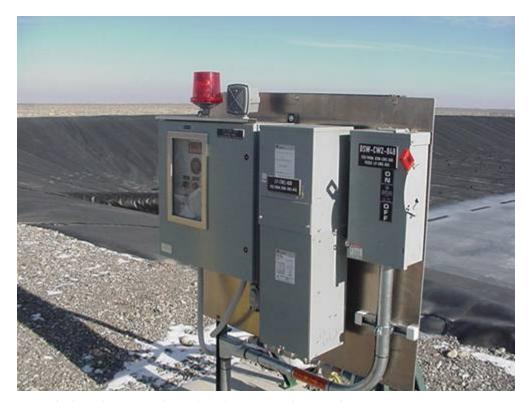
Figure D-20. Leak detection control panel at the evaporation pond.

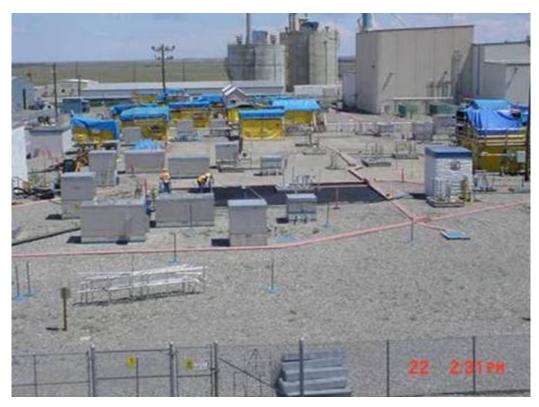
Figure D-21. Laying asphalt inside the tank farm at Site CPP-31.

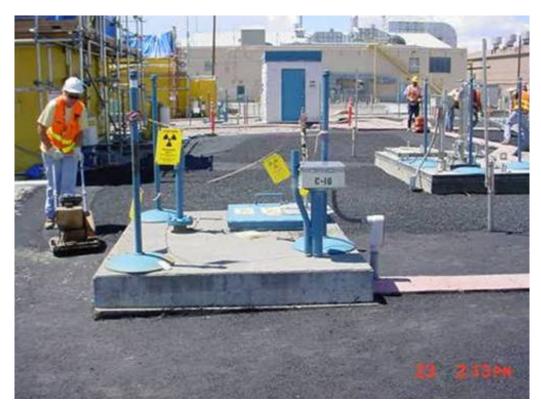
Figure D-22. Laying asphalt at Site CPP-31.

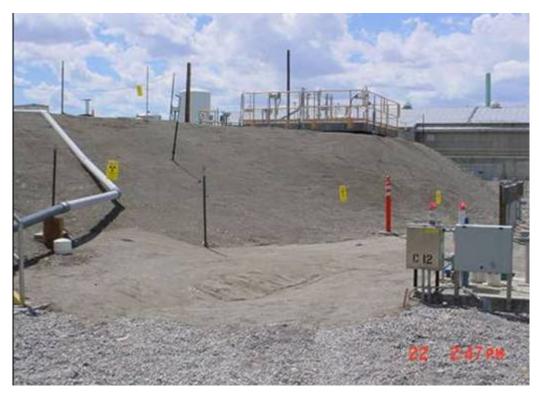
Figure D-23. Preparing Sites CPP-28 and CPP-79 for asphalt.

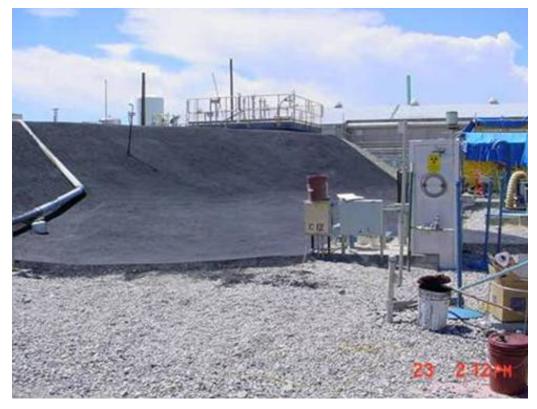
Figure D-24. New asphalt on Sites CPP-28 and CPP-79 inside the tank farm.

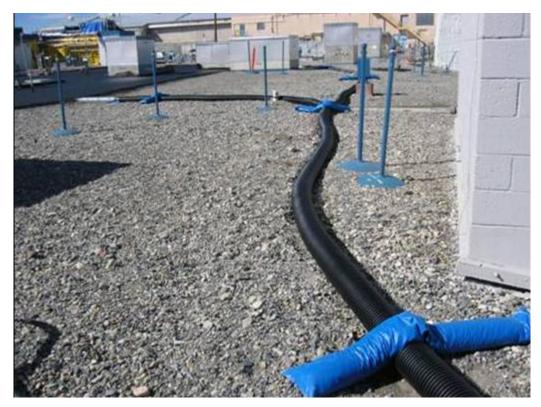
Figure D-25. Drainage piping and ballast tubes inside the tank farm.

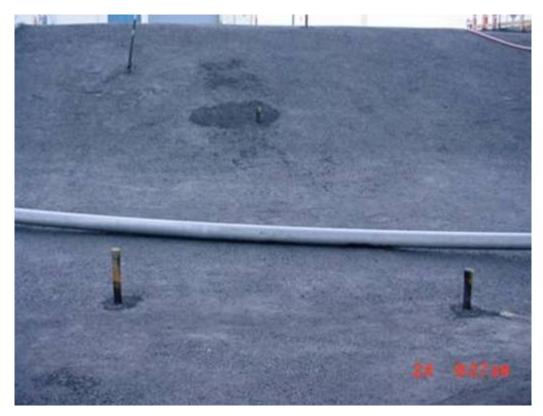
Figure D-26. Asphalt applied around probeholes in soil contamination areas CPP-28 and CPP-79.

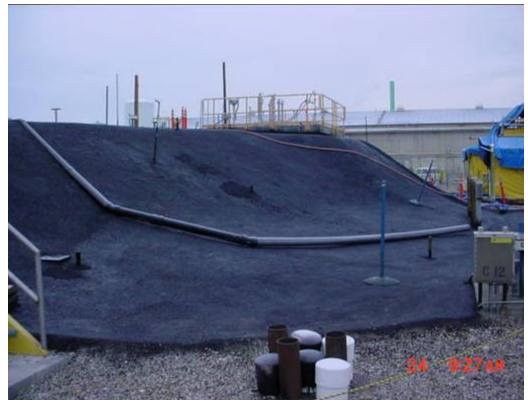
Figure D-27. PVC drainpipe from the top of CPP-79 that has been directed toward the west, in the direction of surface run-off (in accordance with the resolution to Agency Observation #3 from the final inspection on September 22, 2004).
